Hillsborough County Fla.'s Sewer Asset Management Program Pays Immediate Dividends

[EDITOR'S NOTE: This is the final part of a three-part series. The first paper, which appeared in the September/October 2006 issue, examined the Hillsborough County sewer inventory and condition assessment program. The second article, which appeared in September/October 2007, presented the findings of the work. In this article, the County's gravity sewer asset management program is discussed.]

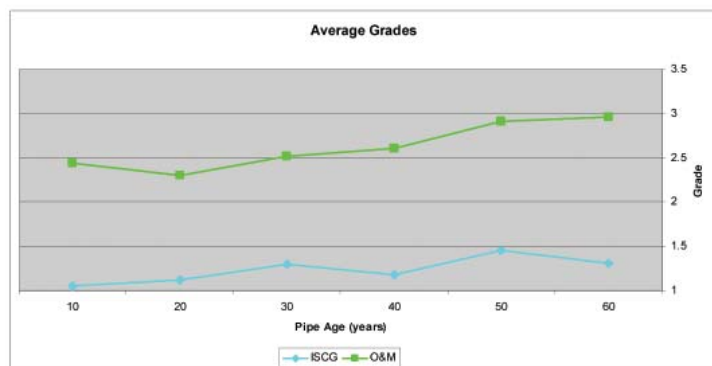
As previously mentioned, the service and structural condition of WRS’s pipelines were better than anticipated. The figure shows the average service and structural condition grades for WRS’s gravity sewers. These grades suggest that the service (O&M) condition of the sewer system is generally good with the older pipelines more prone to accumulation of grease and debris. Although a number of pipelines were found to fall within the fair to good categories, 5,876 pipelines (20.1 percent) fell into the grade 3, 4 and 5 categories. These pipelines were cleaned during the project, resulting in no pipelines with an O&M grade greater than 3 at the completion of the project.

The average structural condition (ISCG) of the sewer system is 1.08. Approximately 1.1 percent of the pipelines were assigned a structural grade of 4 or greater and were inspected with in-line CCTV.

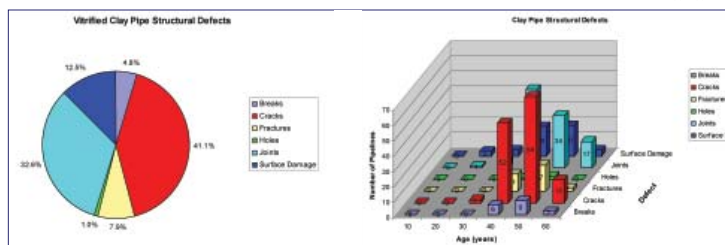
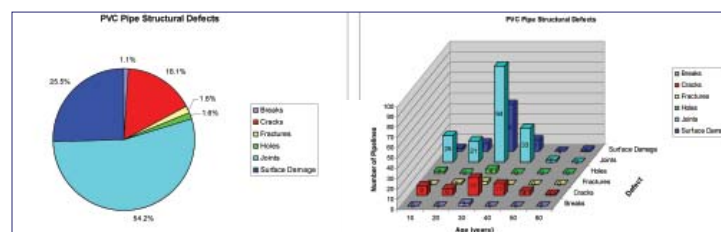
Pipelines: Approximately 2.9 percent (891 pipelines) of the gravity sewer system was observed to contain structural defects. This percentage includes 518 (1.7 percent) VCP pipelines and 373 (1.2 percent) PVC pipelines. The figures present the distribution of the number of pipelines with structural defects by age and pipe material.

Cracked pipe represents the largest category of defects found in defective VCP pipe. Slightly more than 40 percent (213 pipelines) of the defective VCP was found to contain cracked pipe.

Joint defects represented the next highest defect category. Approximately 33 percent (169 pipelines) of the defective VCP was found to contain joint defects. Overall, however, the condition of VCP was determined to be fair to good. VCP pipelines that fell into the grade 4 and 5 categories were televised. These pipelines will be repaired. Considering the fact that only 518 VCP pipelines out of 3,590 VCP pipelines (14.4 percent) were observed to have structural defects, the VCP pipelines are generally in good condition.

Joint defects, primarily of set joints, represent the largest category of defects found in defective PVC pipe. Slightly more than 54 percent (202 pipelines) of the defective PVC was found to contain joint defects. Surface damage defects represented the next highest defect category. Approximately 25 percent (95 pipelines) of the defective PVC was found to contain surface damage. Overall the condition of PVC pipe was determined to be better than good. PVC pipelines that fell into the grade 4 and 5 categories were televised. These pipelines will be repaired. Considering the fact that only 373 PVC pipelines out of 24,015 VCP pipelines (1.6 percent) were observed to have structural defects, the PVC pipelines are generally in “like new” condition.

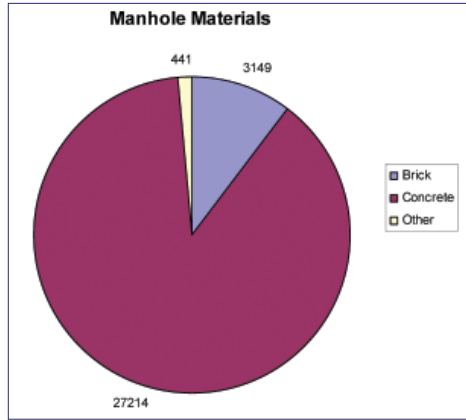
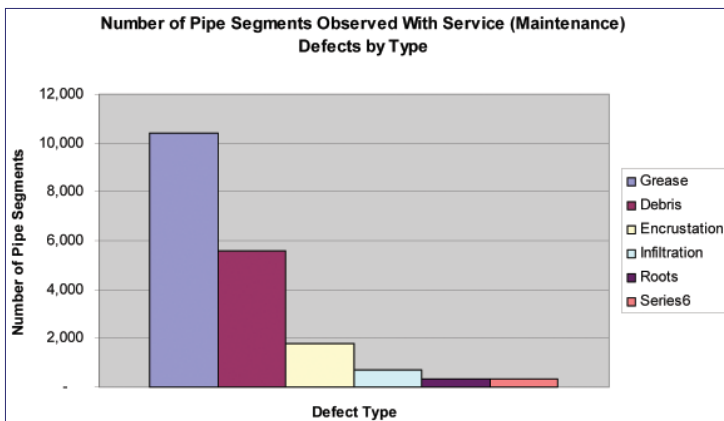
Pipelines: The overall service condition of the gravity sewer system was found to be better than expected. Less than 15 percent were found to have a PACP O&M grade of 3, 4 or 5. However, approximately 65.2 percent (19,084 pipelines) of the gravity sewer system was observed to contain maintenance defects. Maintenance defects were observed within 3,737 VCP pipelines, 15,269 PVC pipelines and 237 pipelines of other materials.

Grease represents the largest category of defects found. Slightly more than 35.6 percent (10,410 pipelines) of the defective pipe was found to contain grease. Debris represented the next highest defect category. Approximately 19 percent (5,559 pipelines) of the defective pipe was found to contain debris. The balance of the maintenance defects included encrustation, infiltration, obstructions and roots. Active or signs of infiltration was observed within 2,476 pipelines.
