# Lights, Camera, Action!

A play in three acts – where the benefits of zoom cameras combined with traditional in-line CCTV are revealed

By: Jason Nelson PMP, Paul J. Batman, P.E., and James Shelton, P.E.

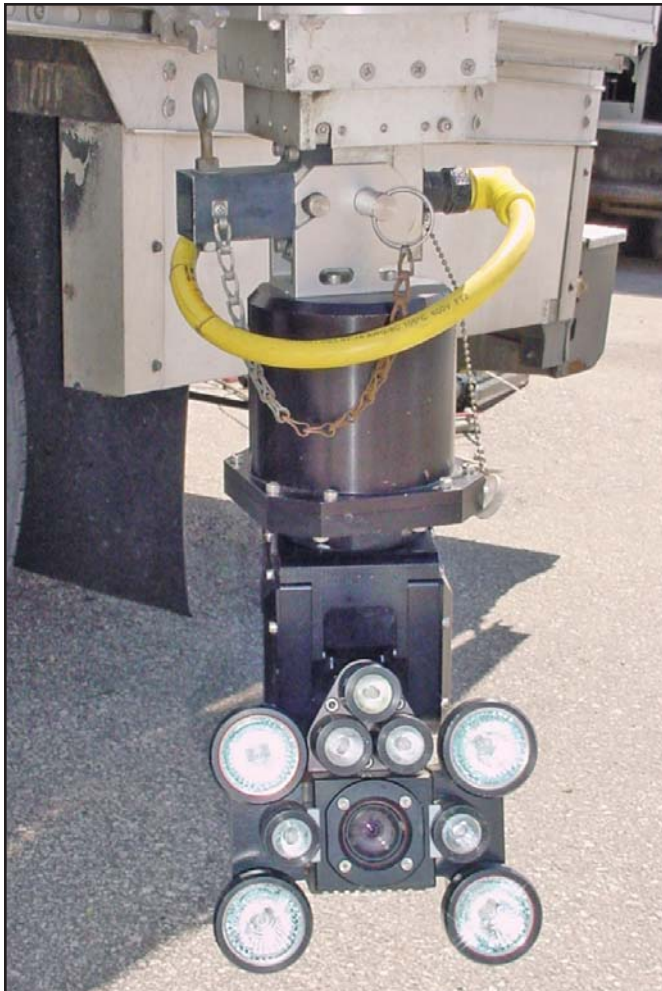
InfraMetrix LLC zoom inspected sewers in the pilot project area using its CUES-IMX zoom camera (see below). The automatically adjusting light head adjusts illumina-

tion on the zoom focal point allowing 50-ft inspections in 6-in. sewers and up to 350 ft in larger sewers. This precision created a high degree of confidence in the inspection results. The efficiency of the zoom setup allowed inspection from both the upstream and downstream ends.
